**STATE CAPITOL REHABILITATION AND
RENOVATION / CAPITOL SQUARE PROJECT**

**SERIES 2 - WYOMING STATE CAPITOL
SD OWNER REVIEW**

LEVEL III SCHEMATIC DESIGN REPORT
VOLUME I OF III

ASSESSMENT AND RECOMMENDATIONS

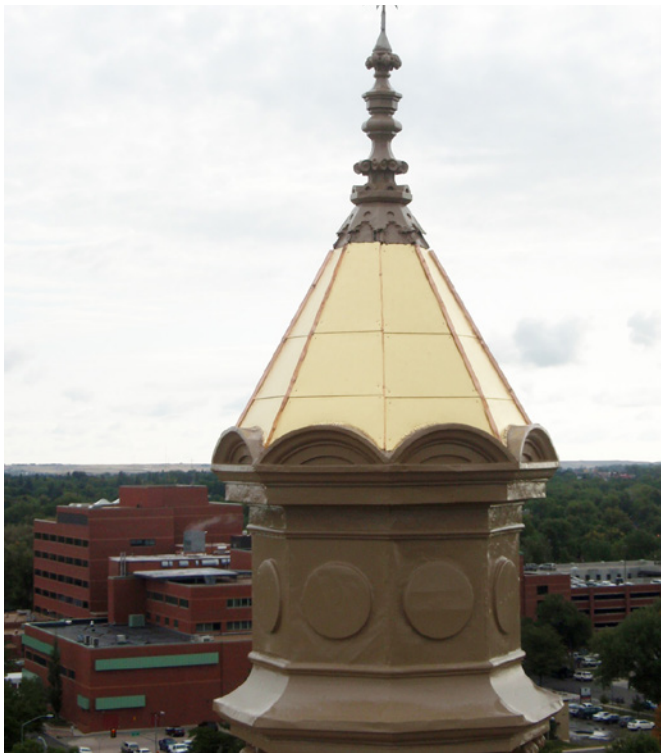
Figure 6.3.2: View of Lantern During 2009 Restoration, Before the Galvanized Metal Rib Covers Were Installed

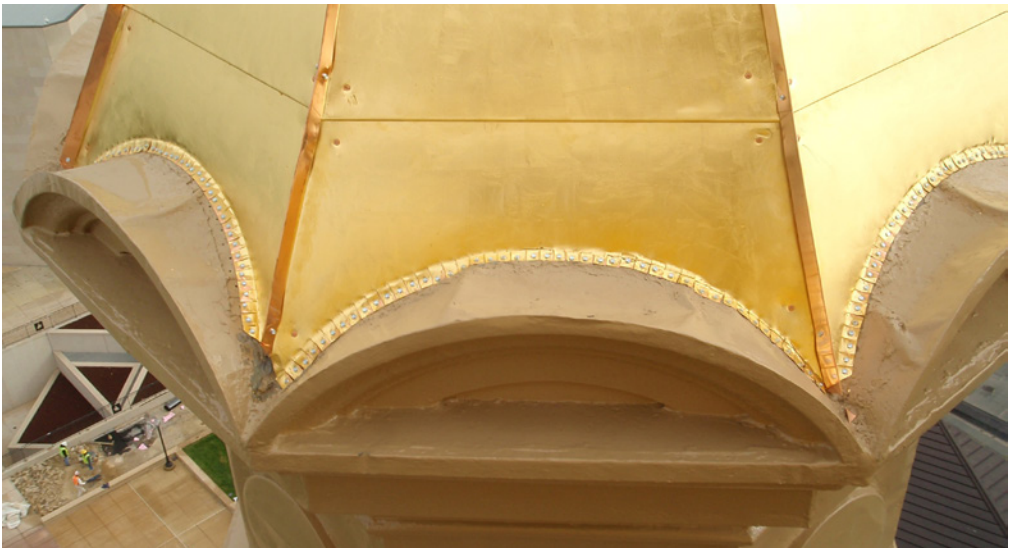
- The photographs indicate that nails were installed through the gilded copper panels, providing routes for water infiltration [Figure 6.3.4].
 - Sealant was installed at the joint between the gilded copper panel and the top of the galvanized metal lunettes [Figure 6.3.3]. The traditional and watertight detail includes the installation of counterflashing.

Figure 6.3.4: View of Detail at Joint Between Lunette and Gilded Copper Panels. The traditional and watertight detail includes the installation of counterflashing. Note nails installed through copper panels.

- Restore structural lantern frame as directed by the Structural Engineer.
- Replace 100% of the wood blocking.
- Remove existing gilded copper panels. Assume 50% replacement and 50% new gilded copper panels. Extend new gilded copper panels to historic configuration.
- Restore finial. Replace missing crocket.
- Replace 100% of the galvanized metal rib covers with new galvanized steel.
- Refer to *Galvanized Metal Treatments, General Approach (General Scope Of Work At Galvanized Metal Where The Metal Will Be Disassembled, Restored And Re-Assembled)* for treatment of galvanized metal at the lantern.
- Install blocking at lunettes to minimize potential damage to these elements caused by hail.

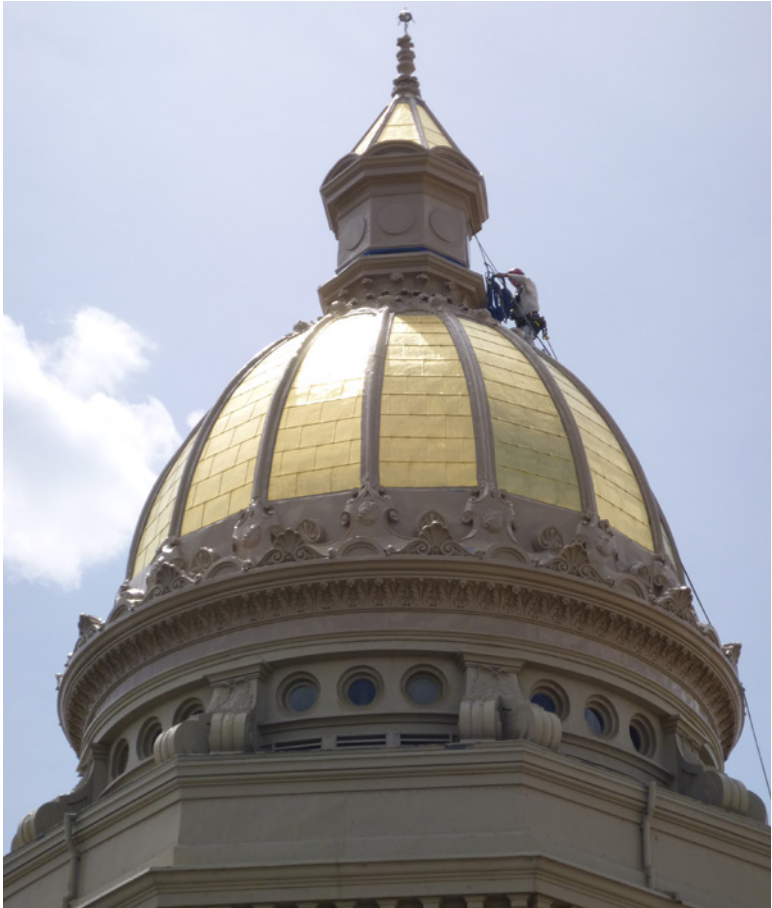
Figure 6.3.5: Dome and Lantern

- Conditions and Detailing at the Dome are similar to gilded copper panel conditions at the Lantern [Figure 6.3.5].
- Photographs of the 2009 restoration and reassembly of the gilded copper panels at the Lantern and Dome provided by the Owner, indicate conditions which do not conform to traditional historic copper detailing and roofing practices and will not provide a watertight Dome and Lantern assembly for the long term [30-50 years].

- Replace wood blocking and sheathing as necessary. Assume 100% of the wood blocking and 30% of the wood sheathing will be replaced. Coordinate work with Structural Engineer.
- Remove existing gilded copper panels. Assume 50% replacement and 50% new gilded copper panels. Fabricate and install new gilded copper panels so that they match the historic gilded panel configuration.

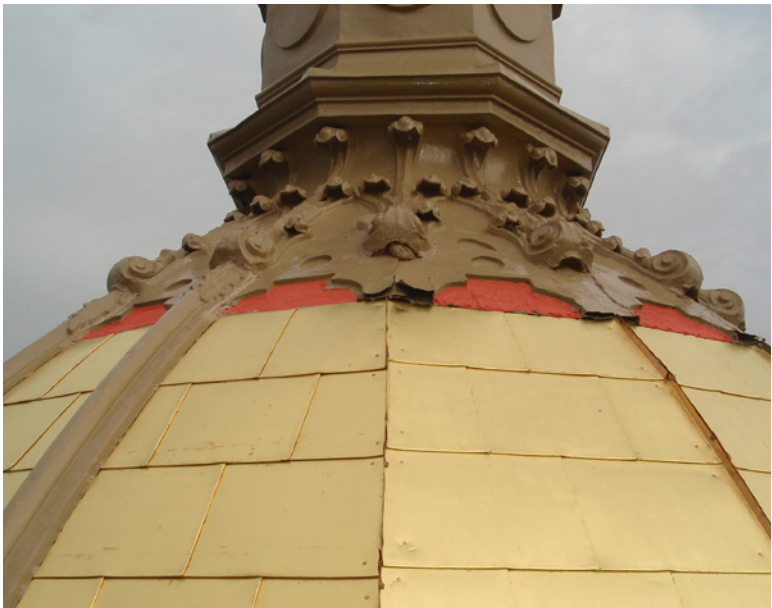
Figure 6.3.6: Detail of Gilded Copper Panels During 2009 Dome Restoration. Note that vertical joints are filled with sealant, rather than the traditional flat-lock or standing seam. The red indicates the additional extent of the historic configuration of the gilded copper panels.

- The photographs indicated that the gilded copper panels originally extended up further and terminated in an ornamental arched pattern [Figure 6.3.6]. Sealant has been installed in the joint between the early painted copper and the newer gilded copper, which represents a short-term repair solution at a vulnerable location.

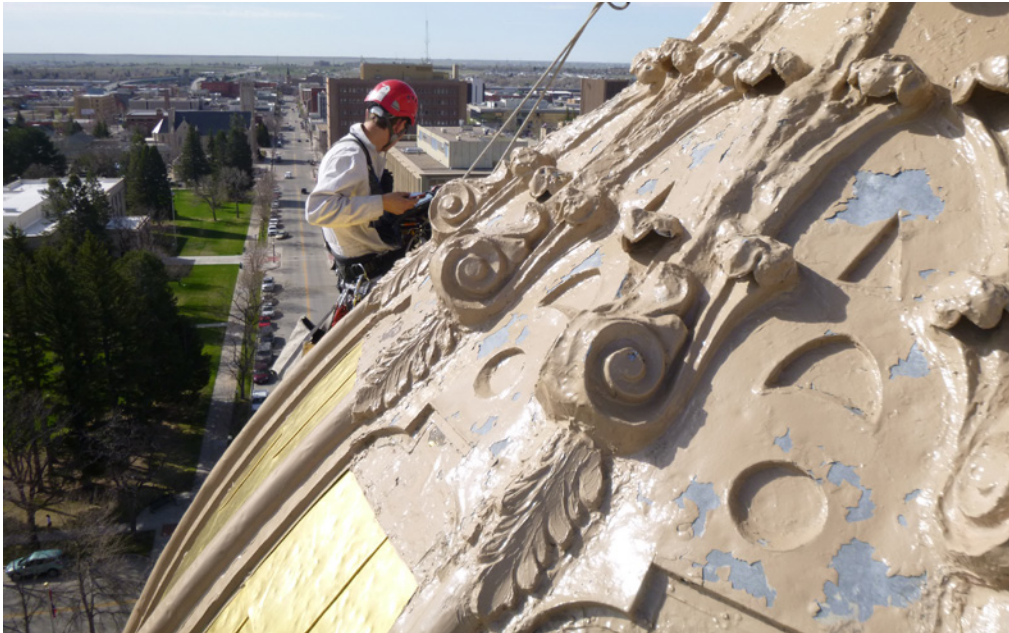
- The base and top of the Dome are clad with galvanized sheet metal with applied lead ornament [Figure 6.3.7]. The galvanized sheet metal is in fair condition, with some open seams, failed paint coatings and minor surface corrosion.
- Galvanized sheet metal with applied lead also comprises the high relief ornament applied to the consoles at the Drum Attic.
- The lead ornament is in poor condition with dents, tears and punctures at many locations and some missing elements. The tears and punctures occur on all sides of the Dome, but are most numerous on the east side. Some of the perforations have been filled with clear silicone sealant and automotive metal patching compounds.
- The base of the dome has a band of projecting foliated ornament. Many of the individual pieces of the ornament are missing. Some pieces of ornament have tears and are loose.

Figure 6.3.7: Detail of the Galvanized Metal Sheet and Lead Ornament at the Top of the Dome.

- Disassemble the galvanized metal and sheet lead ornament at the top and base of the Dome. Assume 50% of the galvanized metal will be replaced.
- Refer to *Galvanized Metal Treatments, General Approach (General Scope Of Work At Galvanized Metal Where The Metal Will Be Disassembled, Restored And Re-Assembled)* in Dome Section of this report for treatment of galvanized metal at the Dome.
- Restore lead ornament. Patch holes, solder open seams, remove dents. Replace missing elements.
- Reassemble and install restored galvanized metal and lead ornament.
- Provide inert material in between dissimilar metals to avoid galvanic action.

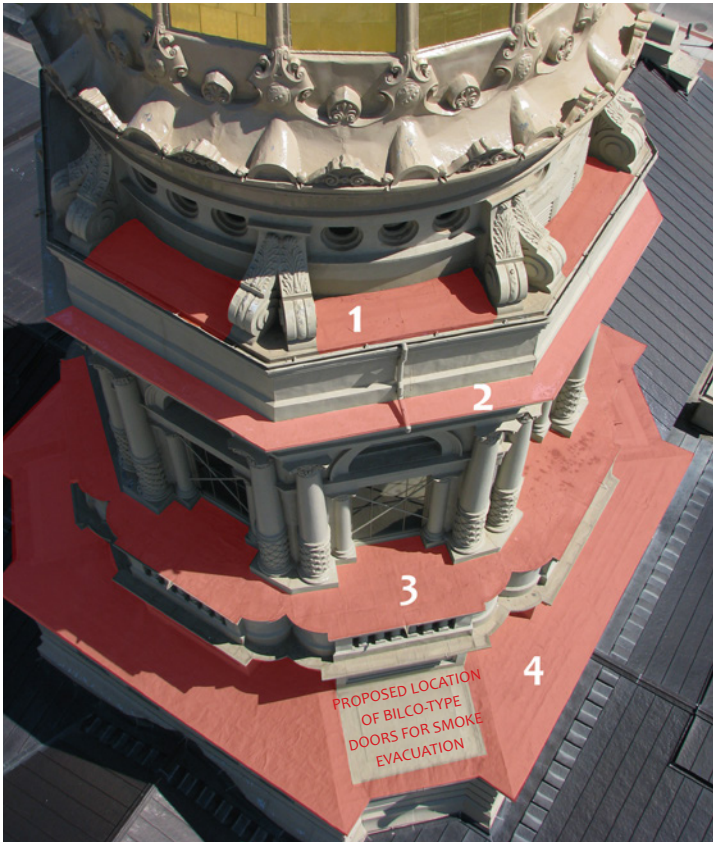
- The deck coatings at the wash surfaces of the Drum above the Base at the Colonnade and at the Attic are in poor condition [Figure 6.3.9]. Typically, the deck coatings have bubbled and lifted from the sheet metal substrate.

Figure 6.3.9: Wash Surfaces (Shown in Red): 1. Mid-Line of Drum Attic Below Consoles; 2. Top of Drum Colonnade; 3. Top of Drum Colonnade Base; 4. Top of Drum Base.

- Replace 100% of the galvanized metal rib covers at the Dome and Lantern with new galvanized steel rib covers matching existing profiles.
- Refer to Figure 6.3.9 for replacement of wash surfaces at Drum with new galvanized metal, including:

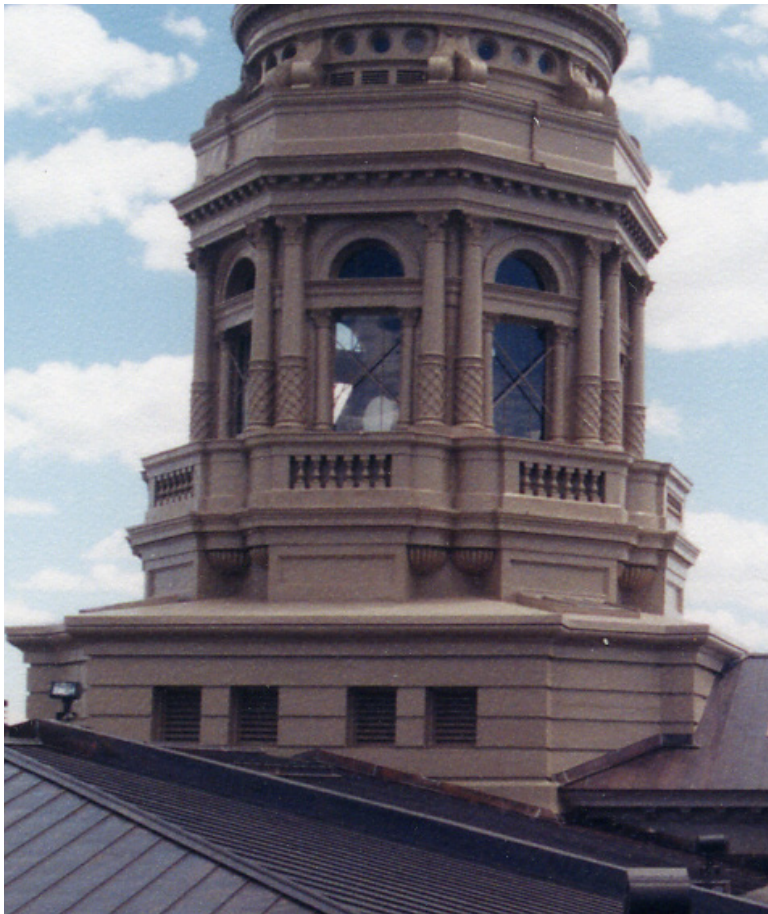
Figure 6.3.17: View of Cast Iron Drum Base.

Proposed Treatment
Drum Base <ul style="list-style-type: none">Remove all paint, rust and mill scale from the cast iron surfaces down to bare metal using needle gun scalers.Coatings shall be: Prime Coat - Tnemec Series N69F Hi-Build Epoxoline II; Intermediate Coat - Tnemec Series N69F Hi-Build Epoxoline II; Finish Coat - Tnemec Series 1071 Fluoronar. Apply primer and one intermediate coat. Finish coat of paint with a sand finish shall be applied after the galvanized metal is reinstalled.Remove wash surface from top of Drum Base and install new galvanized steel wash surface (Figure 6.3.9). Install new Bilco-type doors for smoke evacuation where historic skylights were located. Refer to Roof Section 6.4.1 of this report.Apply reinforced cold fluid-applied membrane (Kemper System) to wash surface. Extend membrane 8 inches up vertical face of Drum Colonnade Base.

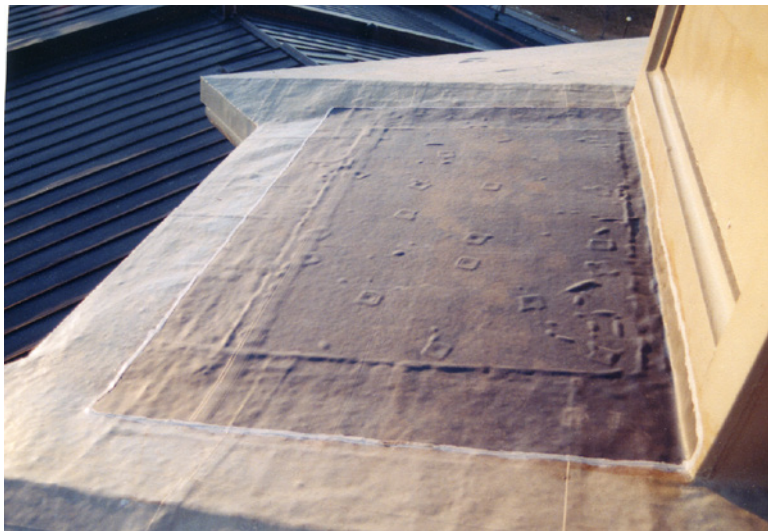
Figure 6.3.18: Location of One of Four Historic Skylights at the Wash Surface on the Top of the Drum Base as Seen from Above.

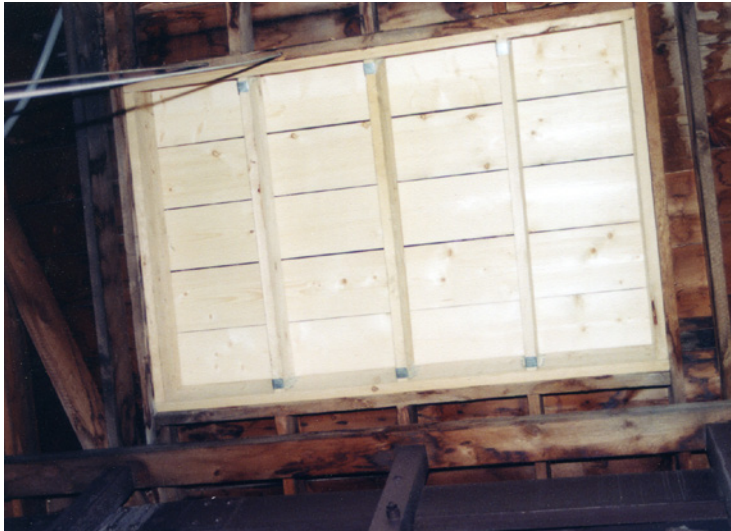
Figure 6.3.19: Location of One of Four Historic Skylights at the Wash Surface on the Top of the Drum Base as Seen from Below in Attic.

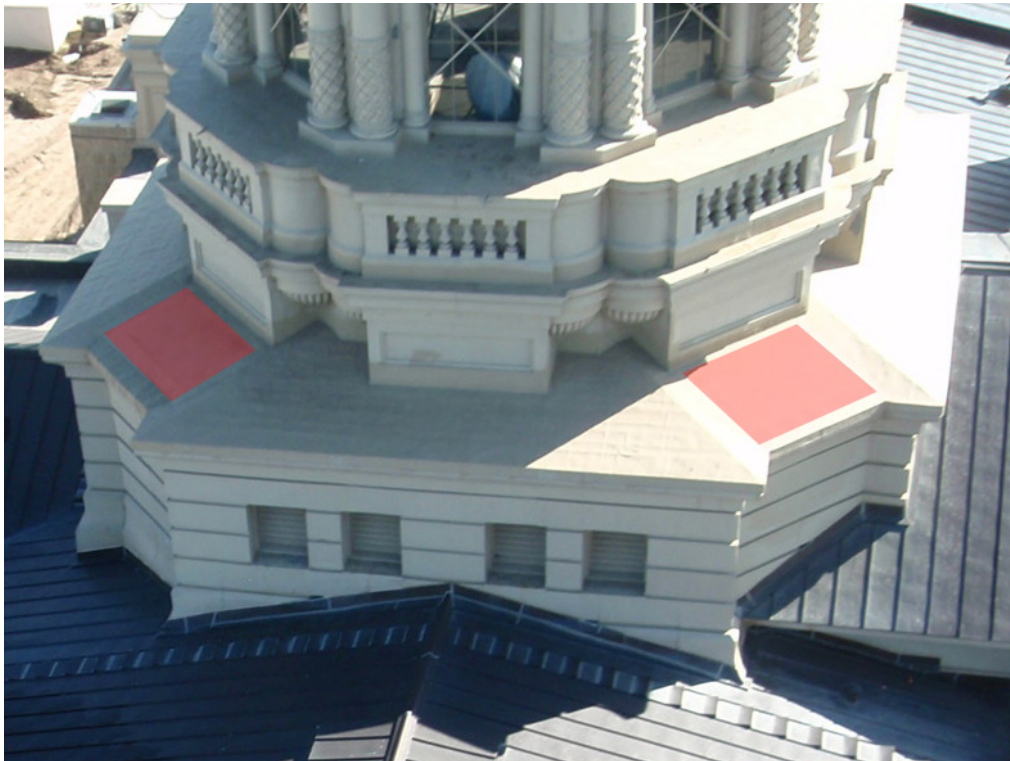
Figure 6.3.20: View of Top of Drum Base Showing Location of Historic Skylights in Red.

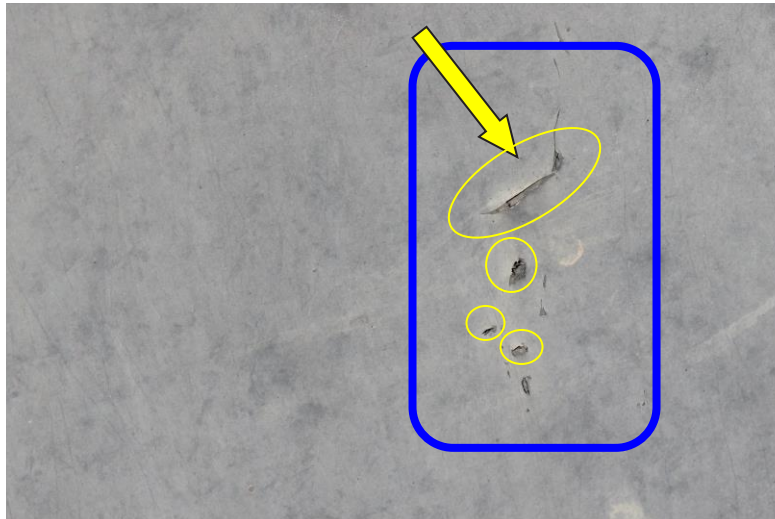
Figure 6.4.1.5 Damage to EPDM Roofing. The arrow points to a 2-inch tear and holes in the EPDM membrane.

- Refer to *Figure 6.4.1.1 - Existing Roofing Diagram* for approximate extent of EPDM roofing.
- The existing EPDM roofing system is a synthetic rubber roofing membrane, approximately seventeen (17) years old.
- Two-inch tears and several holes were observed. These tears appear to be mechanical damage resulting from snow removal operations [*Figure 6.4.1.5*].
- This type of roofing is appropriate for commercial roofs with limited foot traffic and no anticipated mechanical abrasion such as shoveling.
- The EPDM roofing assembly is currently leaking. Loose flashings were observed.
- The EPDM roofing system is near the end of its anticipated life, between 16 and 18 years.

- Remove existing EPDM roofing and replace with a copper flat lock soldered seam roofing system with traditional / historic copper detailing [*Figure 6.4.1.7*].
- The life span of a flat locked, fully soldered roofing system is approximately 75 years, equivalent to the lifespan of the standing seam copper roof.
- **Seams:** All seams to be crimped with a mechanical crimper. Seams to be peened flat, cleaned and soldered [*Figure 6.4.1.7*].

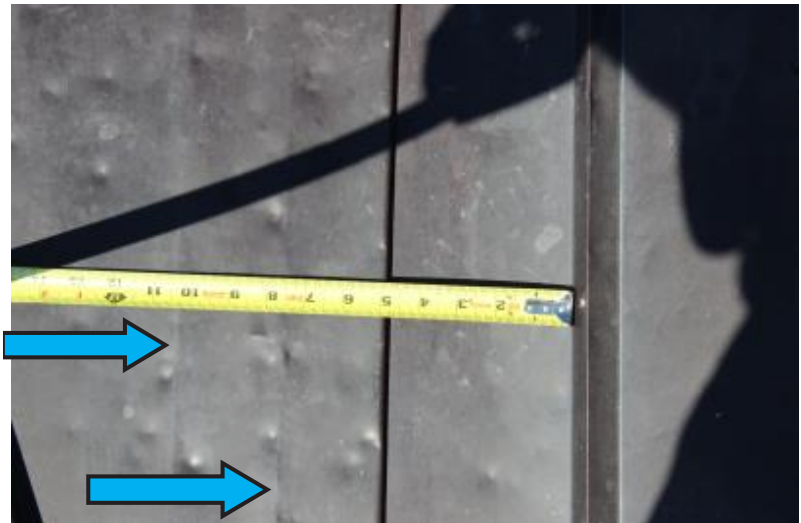
Figure 6.4.1.10 Detail of Existing Copper Valley. The blue arrows point to creases in the copper pans that indicate the edge of the valley below. Although difficult to read, there are only 10 + inches up each side of the valley. This indicates that a 24” wide sheet was used for the valleys, which is inconsistent with historic and accepted roofing practice.

- Minimum 24 oz copper
- Formed from 36” sheet with cleat hem on both edges and inverted “Vee” in center [Figure 6.4.1.12].
- Provide elevated walkway system to restrict foot traffic and prevent damage to replacement valleys.

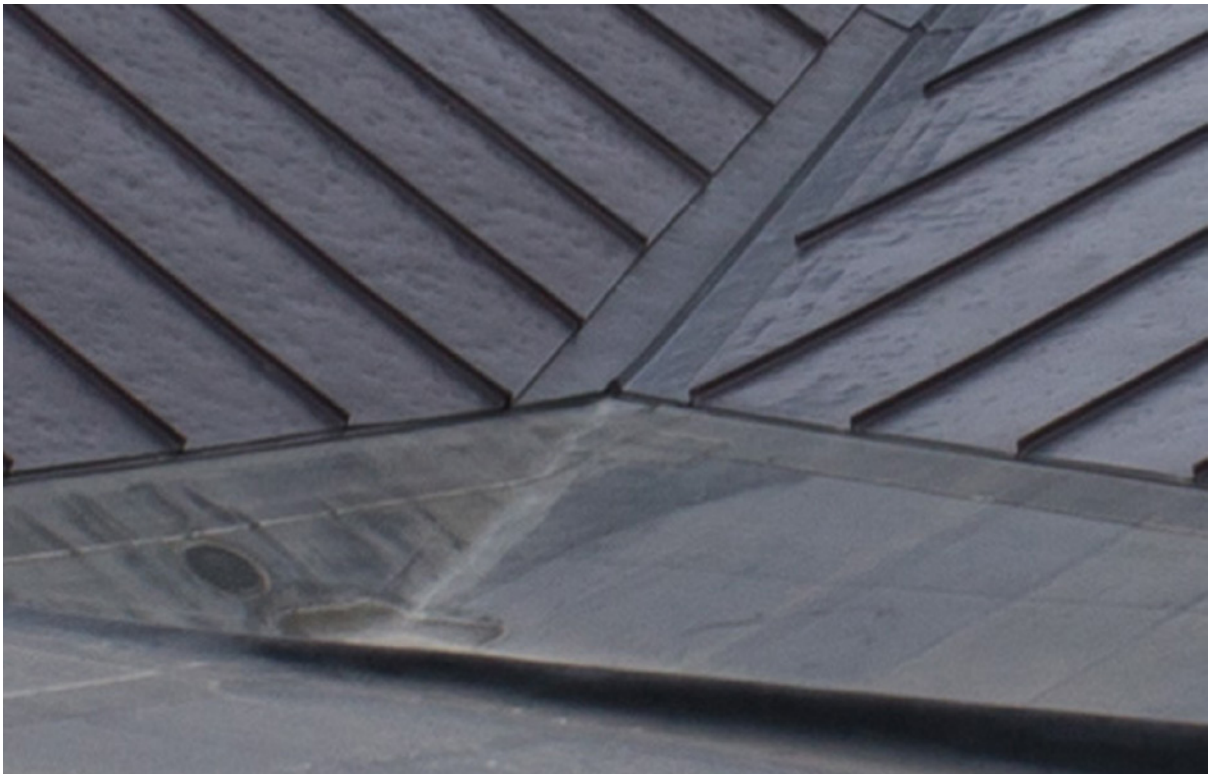
Figure 6.4.1.11 Detail of Existing Copper Valley with Inverted “Vee” Center. This indicates that the valley was fabricated from a 24” sheet rather than a 36” sheet, which is the traditional detail.

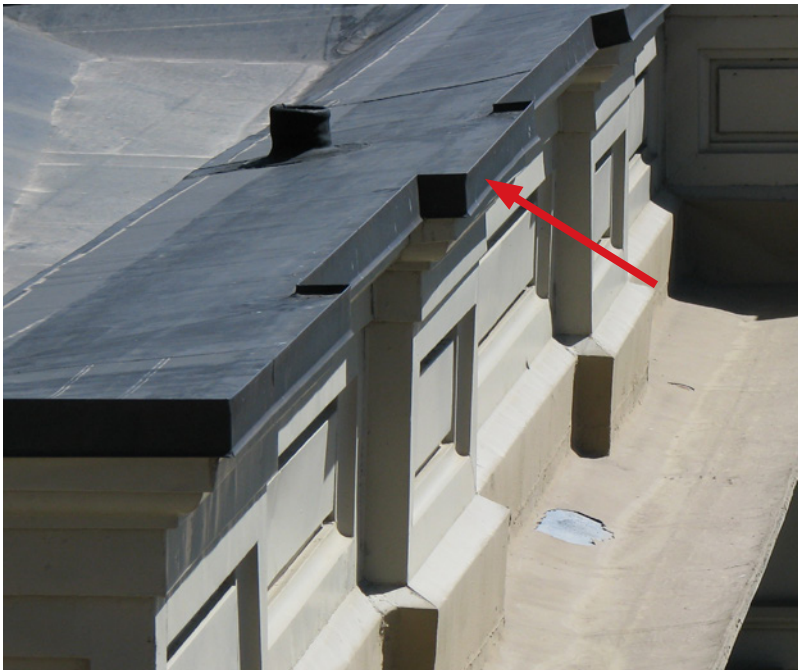
Figure 6.4.1.18 Copper Fascia Terminates EPDM Roofing.

- Remove fascia and EPDM and install lead-coated copper coping to prevent the staining of the galvanized metal and masonry [[Figure 6.4.1.25](#)].

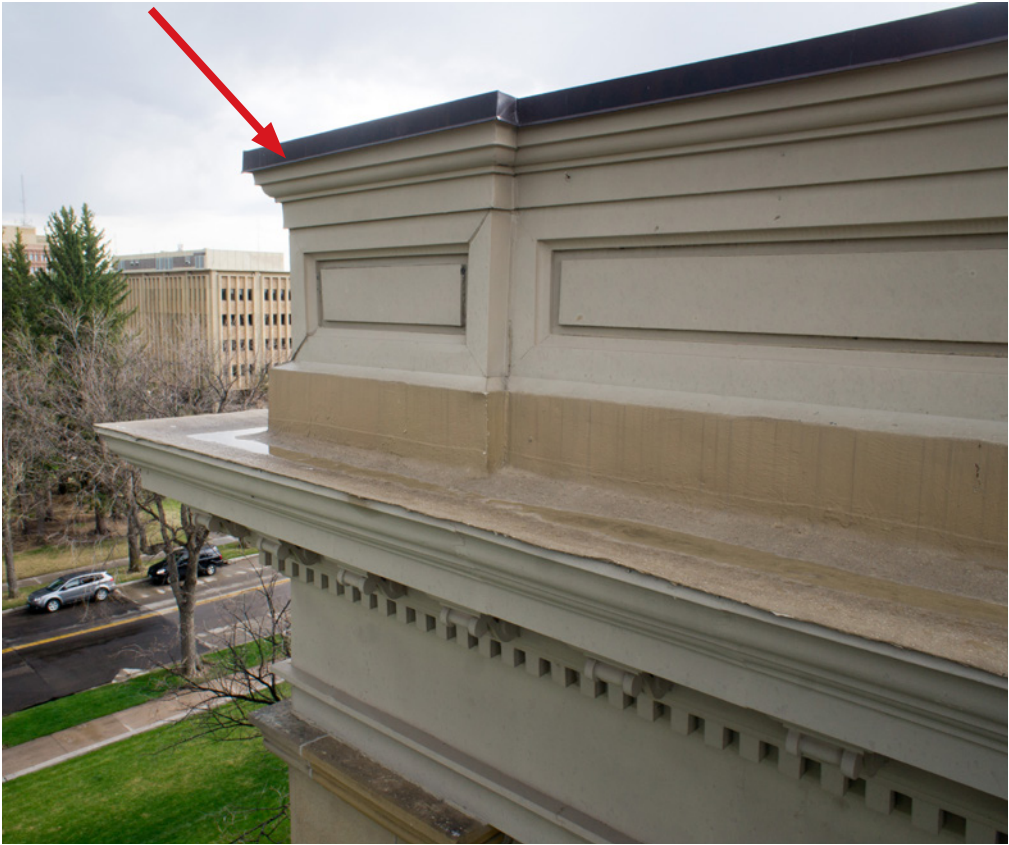
Figure 6.4.1.19 Copper Fascia Terminates the EPDM and Laps over Galvanized Metal.

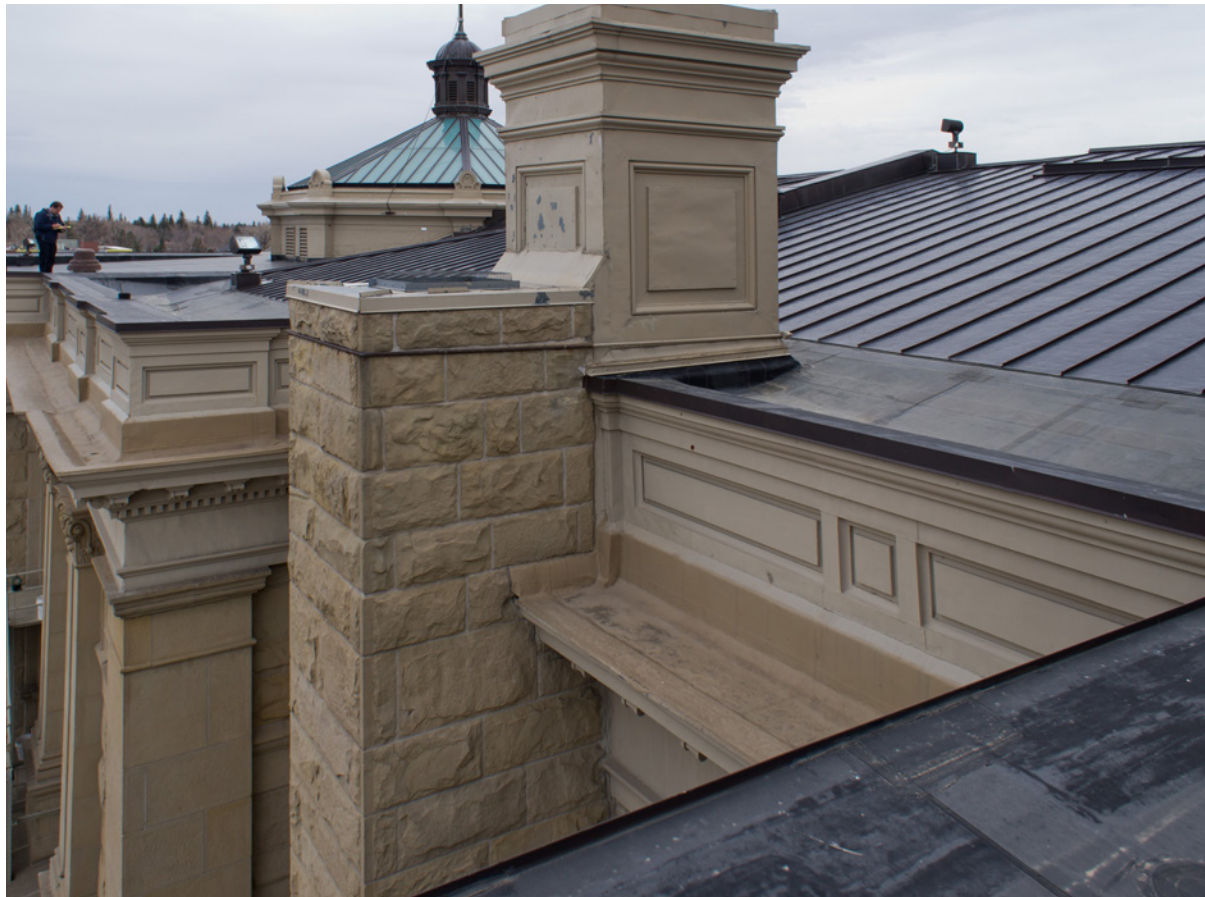
Figure 6.4.1.23 View of EPDM Built-In Gutter.

- Refer to *Figure 6.4.1.1 - Existing Roofing Diagram* for extent.
- EPDM fully adhered to 1/2” plywood substrate.
- Flashing stripping is deteriorated.
- EPDM is damaged and at the end of its useful life.

- Remove EPDM and install full sheet straps formed from 32oz. cold rolled copper, per *Figure 6.4.1.25*.

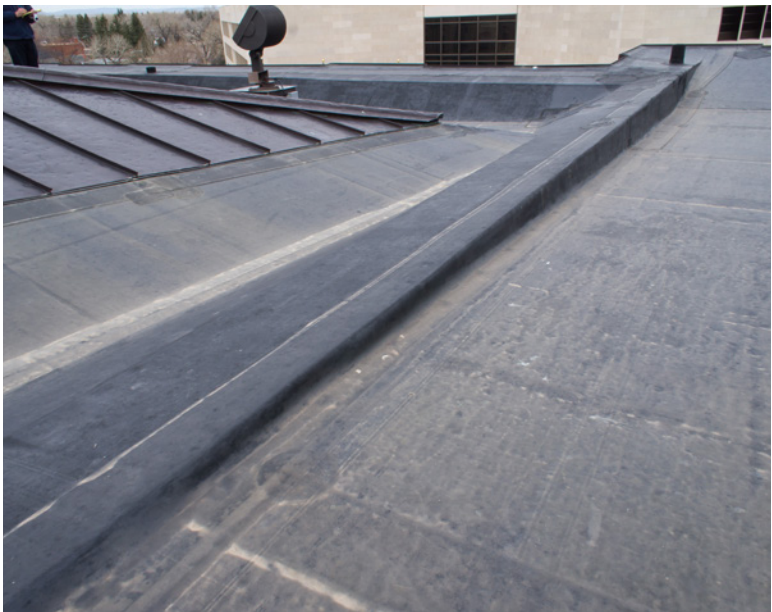
Figure 6.4.1.26 View of Existing EPDM Built-In Gutters.

- Refer to [Figure 6.4.1.1 - Existing Roofing Diagram](#) for approximate extent.
- Gutters consist of EPDM adhered directly to the plywood substrate [[Figure 6.4.1.26](#)].
- There are no provisions tying the existing copper roofing into the replacement gutter.
- EPDM is not the appropriate material to use in a gutter application when a copper standing seam roof is located directly above it, because the life span of EPDM is significantly less than copper. In order to replace the EPDM gutter without replacing the copper roof, it would be necessary to dismantle portions of the copper roofing.

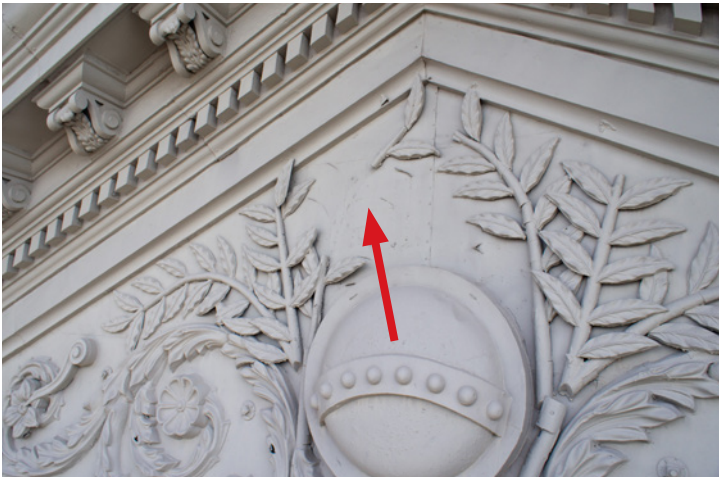
Figure 6.4.2.10 Typical Ornament at the Pediments. At some locations the ornament has broken or is missing, as indicated by the arrow.

- All missing ornament shall be fabricated and installed on the front of the assembly [[Figure 6.4.2.10](#)].
- After repairs are complete and while assembly is on the ground, apply primer and one coat of high performance paint. After the galvanized metal is reinstalled, apply second coat of high performance paint with a sand finish. Coating materials shall be: Prime Coat: Tnemec Series N69F Hi-Build Epoxoline II; Intermediate Coat: Tnemec Series N69F Hi-Build Epoxoline II; Finish Coat: Tnemec Series 1071 Fluoronar).

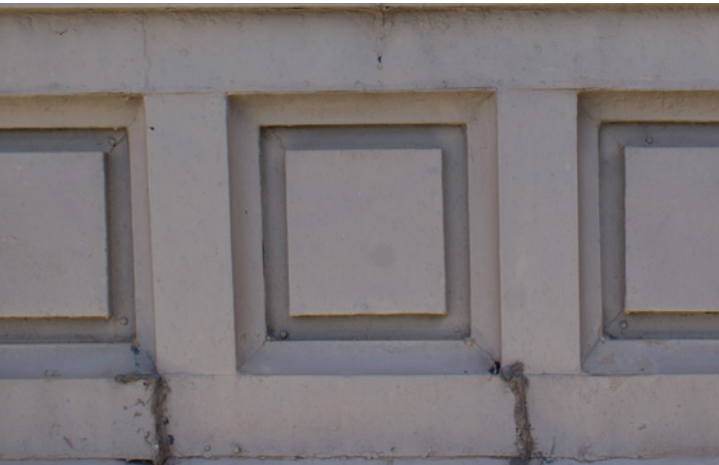
Figure 6.4.2.11 Many Of The Joints Have Been Sealed With Sealant, Which Is Visually Obtrusive And Only Functions As A Short-Term Repair.

- Multiple layers of paint failure.
- Dents, buckles and creases.
- Joints filled with sealant [Figure 6.4.2.11].
- Base of parapet wall coated with a fluid applied material.
- Overall fair to good condition.

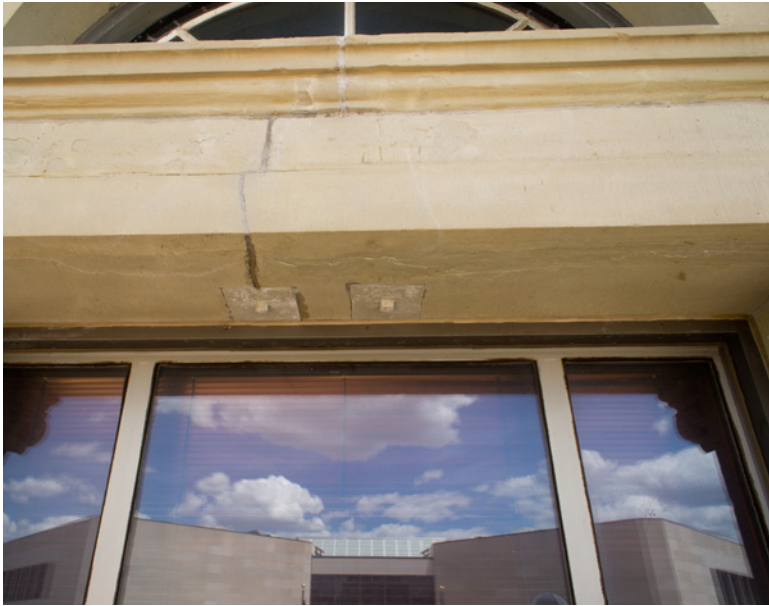
Figure 6.4.3.5: Previous Repair with Square Plates, Rods, and Bolts [at Cracked Stone Lintels].

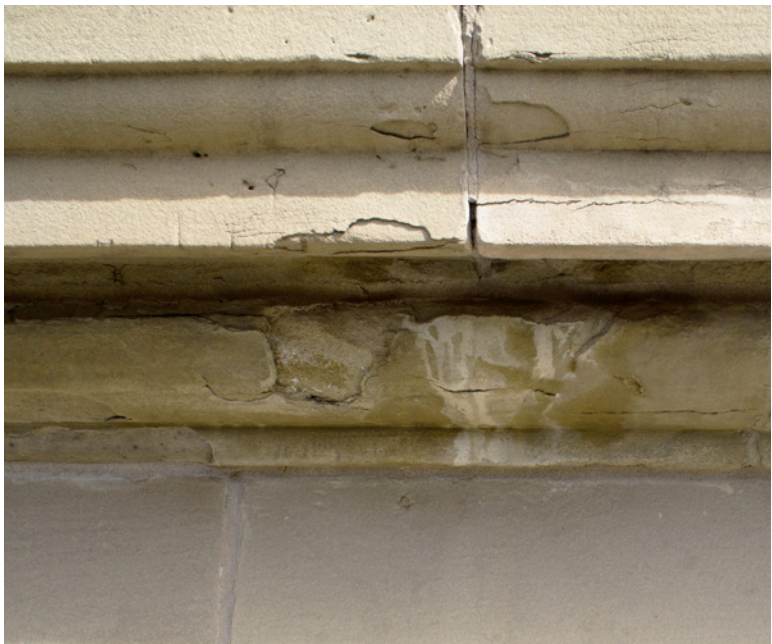
Figure 6.4.3.16: Severe Distress and Deterioration at the Cornice Units Above the South Entrance. The distress includes delamination, erosion, cracking and efflorescence.

- At stones, which have lost more than 1/8-inch and less than 1/2-inch of their surface, tool the stones to match the texture and tooling of the adjacent sound stone or provide stone dutchman repair. The stone units should be tooled so that there are no ledges at the joints and water is shed away from the building. Assume 30% of these repairs will be stone dutchman repairs.

- At severely delaminated or eroded sandstone units (stone loss greater than 1/2-inch), replace stone unit entirely.
- Apply a cold-fluid applied membrane to 100% of the exposed top surfaces of the stone pilaster capitals, located directly below the galvanized metal entablature and to 100% of the top surfaces of the 1890 column bases.

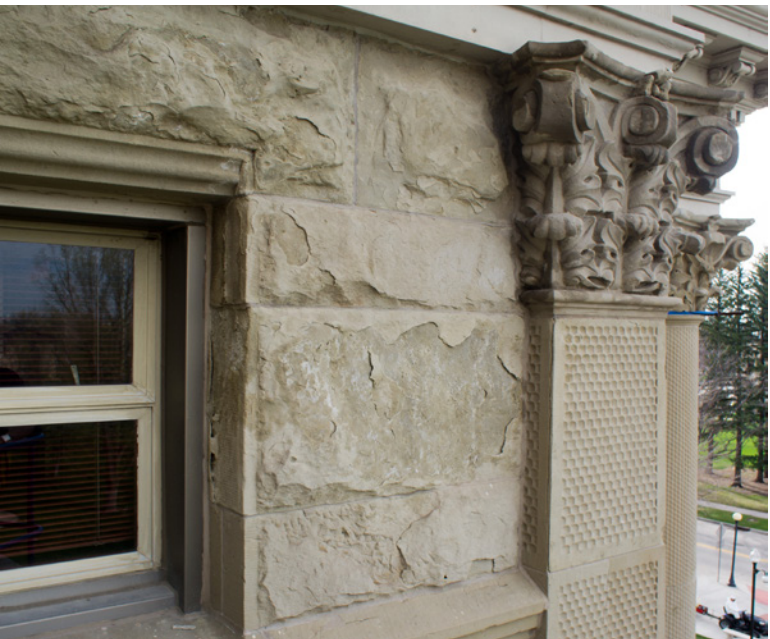
Figure 6.4.3.15: Delaminated Stone at South Portico Where There Is a Leaking Internal Leader.

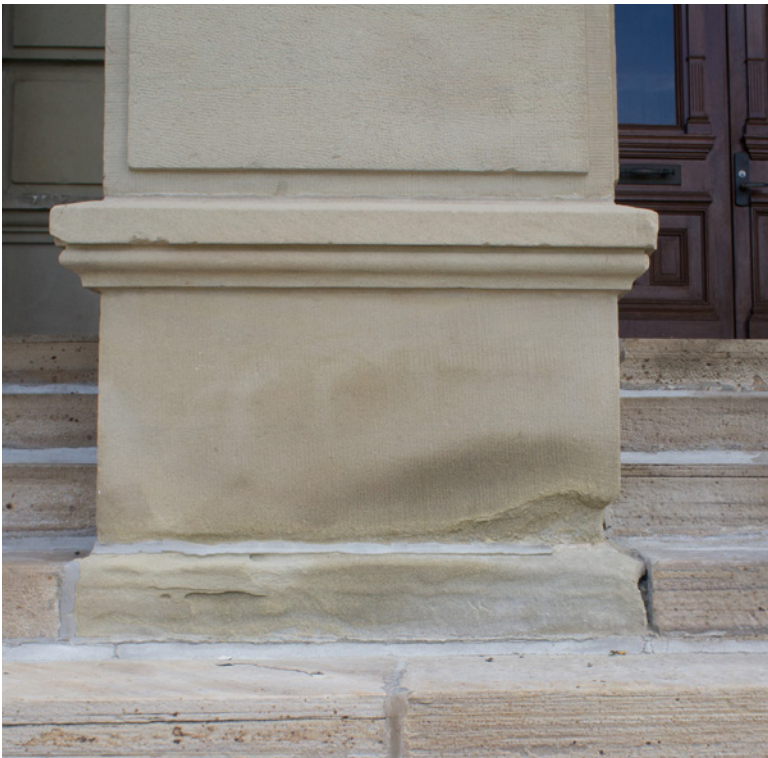
Figure 6.4.3.18: View of Severe Erosion at West Entrance Due to the Use of De-Icing Salts.

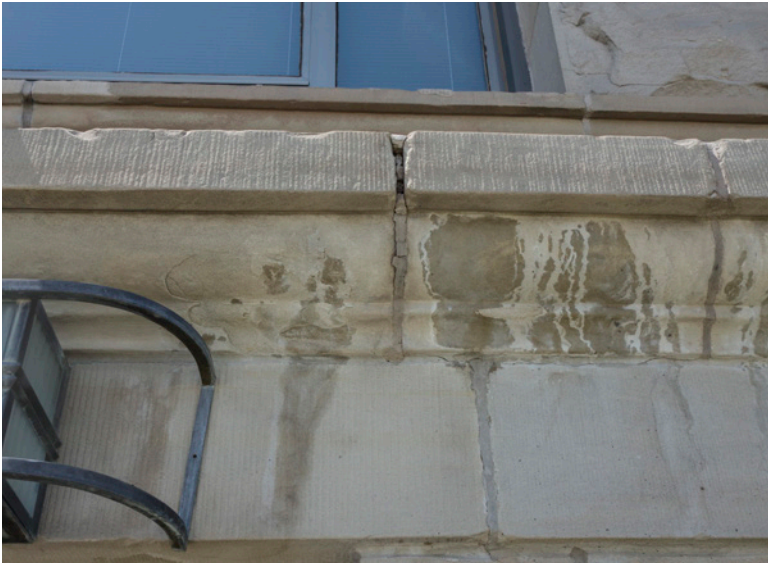
Figure 6.4.3.26: Typical Staining Patterns at Cornice.

- The Design Team recommends conducting cleaning tests to determine the gentlest methods available to clean the stone. The cleaning tests will be designed to remove the following soiling:
 - atmospheric soiling
 - efflorescence
 - guano
 - biological staining.
- Assume that the buiding will be cleaned in its entirety with detergents, low-pressure wash, and chemical cleaners.

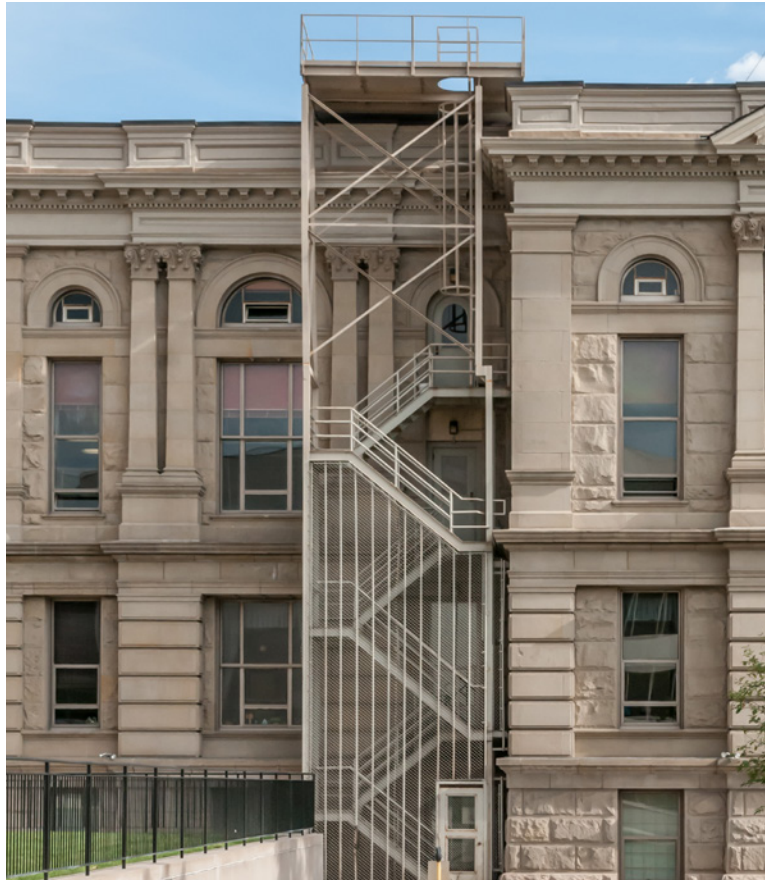
Figure 6.4.3.30: Egress Stair installed at the North Elevation in 1958.

- Stairs and Vestibules: Damage was done to the masonry during the installation, resulting in both large and small spalls in both flat and profiled stone. There appears to be some masonry staining related to the application of adhesives/epoxies used during the installation.

- Carefully remove exterior fire stairs.
- Carefully remove glass vestibules at North Elevation, Garden Level.
- Restore damaged masonry by stone dutchman repairs and stone unit replacement, per requirements outlined earlier in this section.
- Replace all missing sills and lintels with new stone units, per requirements outlined earlier in this section.
- Repair spalls with stone dutchman, per requirements outlined earlier in this section.

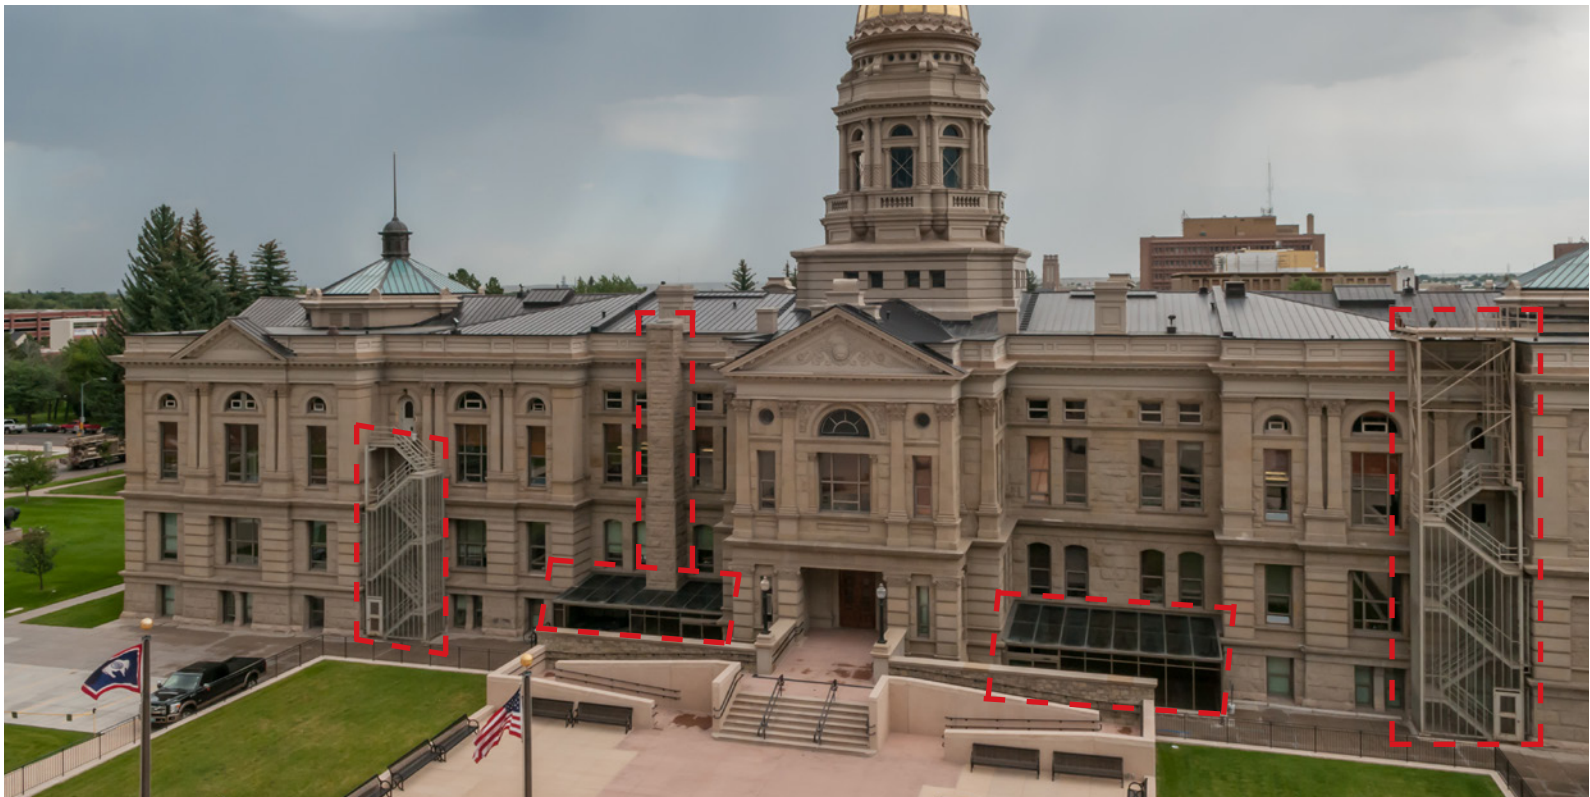
Figure 6.4.3.32: North Elevation, ca. 2013, Showing Locations of Egress Stairs, Glass Vestibules, and Chimney.

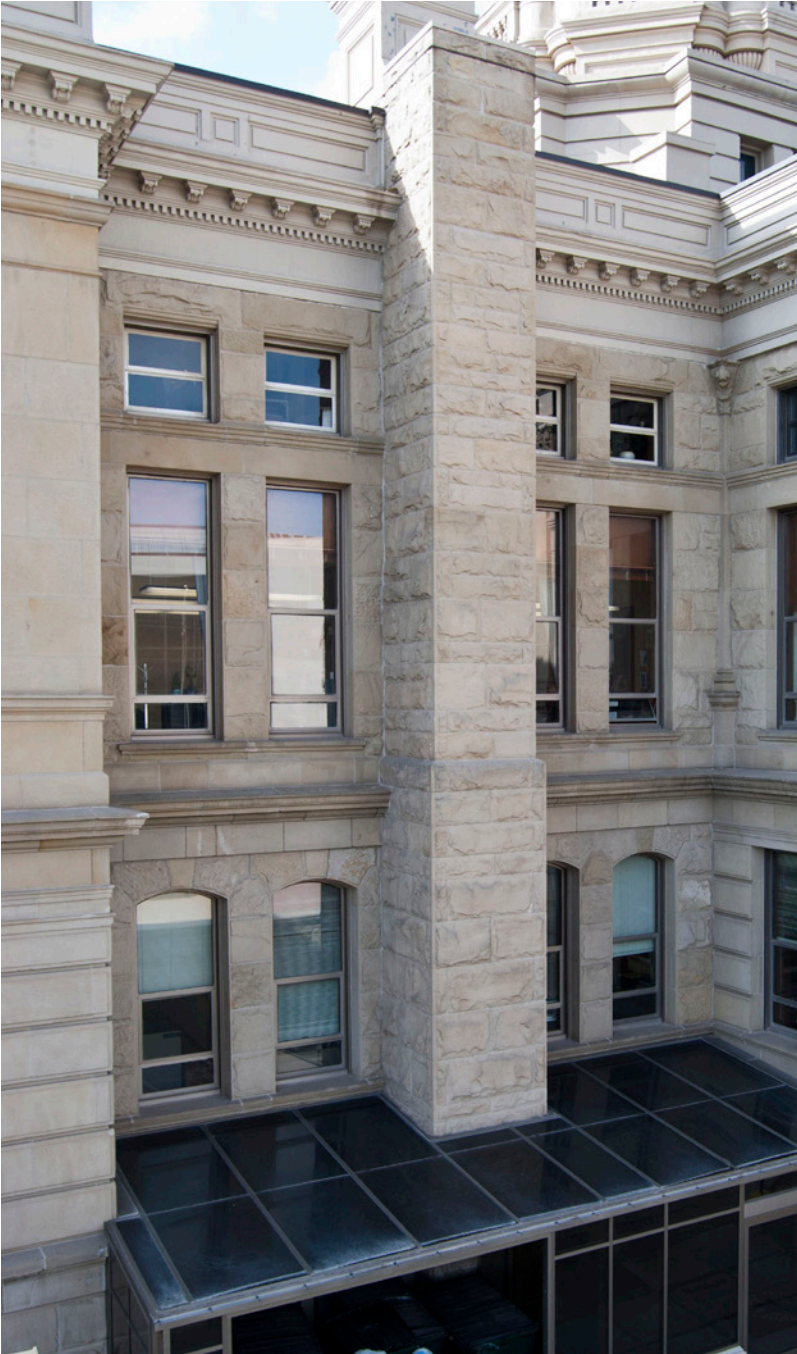
Figure 6.4.3.33: Stone Chimney at North Elevation.

- Coordinate work with Structural Engineer.
- Remove stone chimney and restore stone wall.
- Assume that 100% of the stone behind the chimney and approximately one foot on either side of the chimney shall be replaced with new stone and/or repair of existing stone.

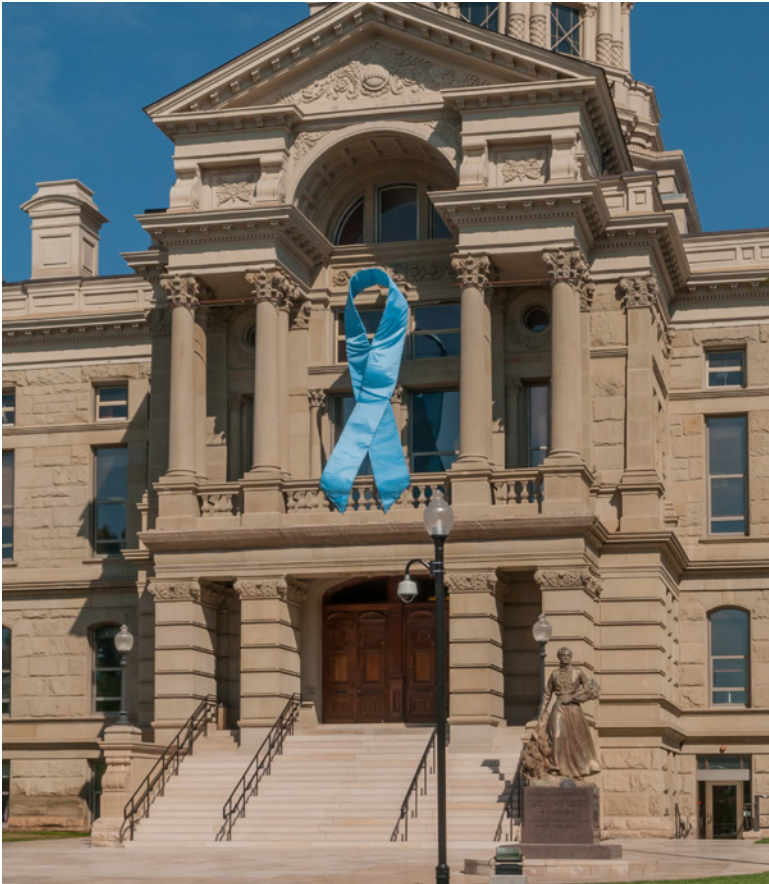
Figure 6.4.3.36: View of South Entrance Stairs.

- The South Entrance Stairs were replaced with new stone in recent restoration campaigns [Figure 6.4.3.36].

- Remove metal railings.
- Carefully disassemble South Stairs and portions of cheek walls as necessary to remove steps; salvage sound stone for reuse.
- Protect and store stone units for repair and reassembly.
- Protect masonry support structure.
- Reconstruct stairs. Replace/reuse stone treads. Assume 50% of the treads will be replaced.
- Reassemble stairs.
- Provide new metal railings with built-in lighting.

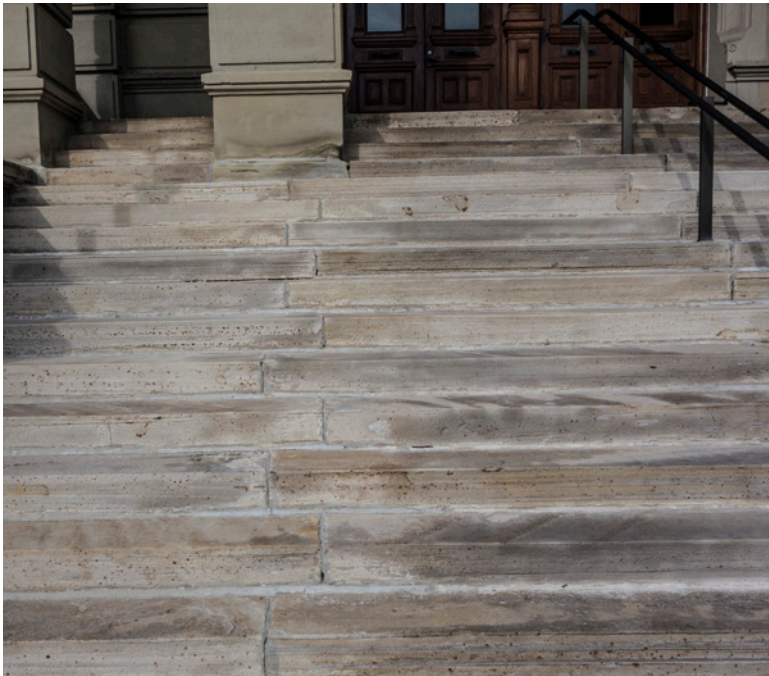
Figure 6.4.3.37: View of West Entrance Stairs.

The West Entrance Stairs are in poor condition. There are wide, open joints and spalled, eroded stone throughout [Figure 6.4.3.37].

- There are areas where the application of deicing salts has severely eroded the stone.
- There are wide, open joints, efflorescence and active water infiltration evident in the brick support structure below the stairs.

- Remove metal railings.
- Carefully disassemble West Stairs and cheek walls
- Salvage sound stone at steps for reuse in dutchman repairs at other locations on building.
- Salvage cheek walls for repair and reassembly.
- Protect masonry support structure.
- Rebuild brick structure supporting stairs as directed by the Structural Engineer. Repoint 100% of brick structure supporting stairs.
- Reconstruct stairs and reassemble cheek walls. Assume replacement of 100% of the stone treads. Assume 50% replacement of cheek walls.
- Provide new metal railings with built-in lighting.
